ADDITIONAL RESULTS ON SPACE ENVIRONMENTAL EFFECTS ON  
POLYMER MATRIX COMPOSITES — EXPERIMENT AO180

R. C. Tennyson  
University of Toronto Institute for Aerospace Studies  
Toronto, Ontario, Canada  
M3H 5T6

ABSTRACT

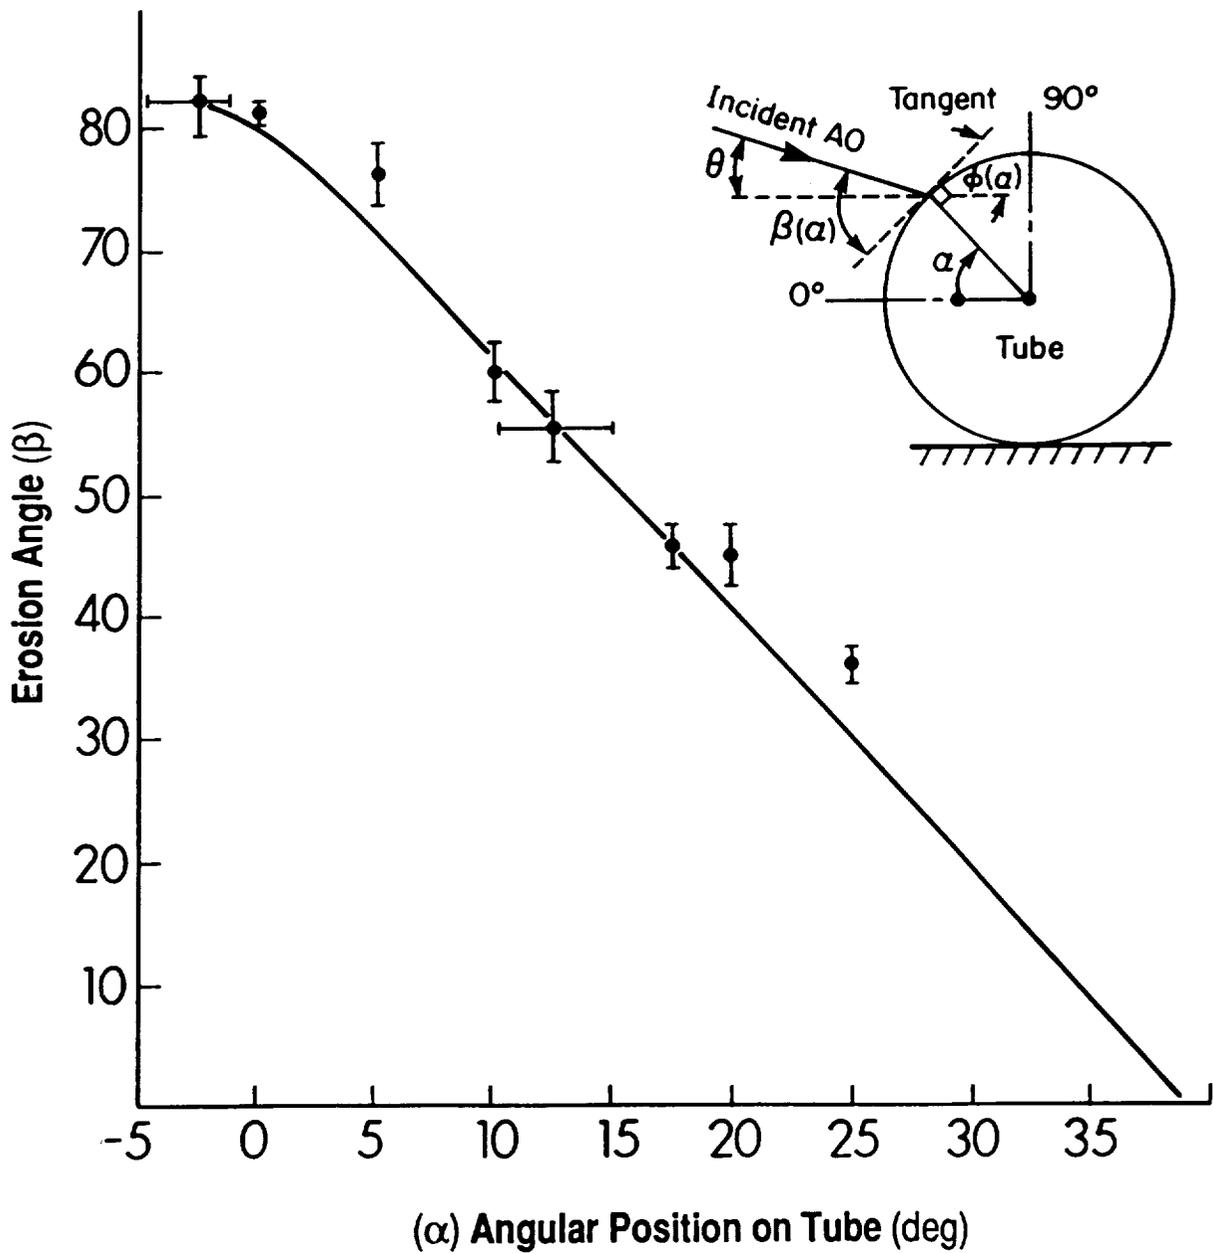
Fig. 4 Variation in Erosion Angle ( $\beta$ ) with Angular Position ( $\alpha$ ) around Boron/Epoxy Tube [SP-290, ( $\pm 45^\circ$ )<sub>4S</sub>]
